NASA
**RL10 IGNITION LIMITS TEST
FOR SHUTTLE CENTAUR**

FINAL REPORT

CONTRACT NAS3-22902

**Prepared by
United Technologies Corporation
Pratt & Whitney
Government Products Division
P.O. Box 109600, West Palm Beach, Florida 33410-9600**

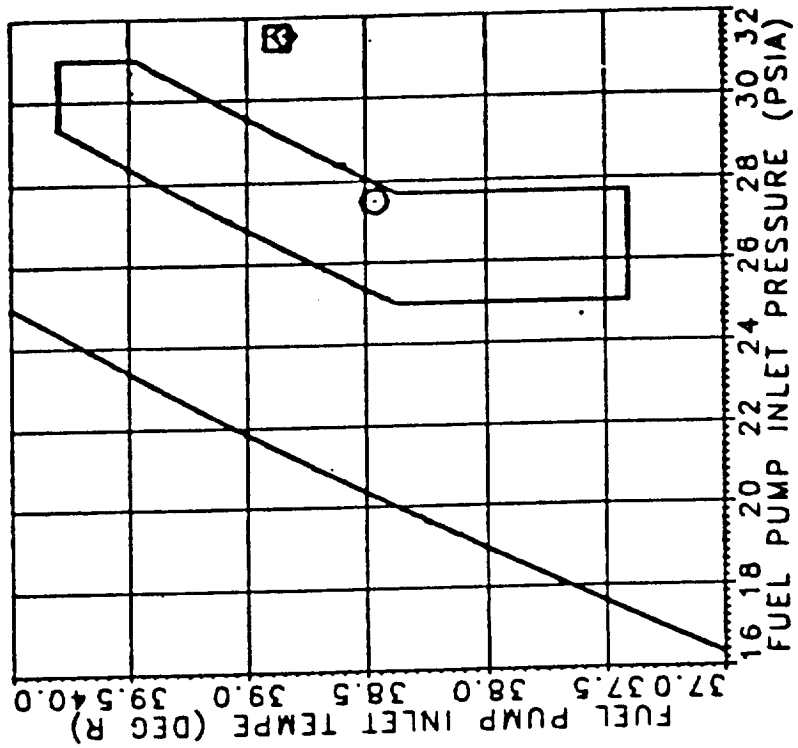
Figure 1. Engine Conditions at Which No-Lights Occurred

The Shuttle/Centaur ignition investigation was originally prompted by three no-lights during Shuttle/Centaur RL10A-3-3B testing. Figure 1 shows the engines and conditions at which these no-lights occurred. To investigate these occurrences, an ignition investigation was run on engine XR105-3 (runs 35-41). This study concluded that the igniter mixture ratio needed to be increased to ensure that the igniter was within the ignition range. Also, the need for conducting tests with evacuated cooldown valves was demonstrated. (Note: During Centaur operation the RL10 cooldown valves discharge to high altitude vacuum during the cooldown. This process is simulated during ground test by "evacuating" the cooldown valve discharge system with a steam ejector. This process is not routinely used due to the potential for contaminating the engine with water from the steam system and also due to steam consumption. It is utilized when required for special tests). Start transients with evacuated cooldown valves were shown to have a lower unlit chamber pressure, and slightly higher oxidizer/fuel (O/F) mixture ratio, than those with non-evacuated cooldown valves. Hence, it is possible to be within the ignition region with non-evacuated cooldown valves and out of it with evacuated valves. Appendix C gives more details of the XR105-3 testing along with a summary of the runs made. This test series was concluded prematurely by water contamination of the engine, however, the need for further testing was apparent. Therefore, engine XR103-3 was run to investigate igniter oxidizer plumbing schemes and increased igniter oxidizer flow area to increase igniter flow. In the meantime, a hydrogen leakage path was discovered in the igniter. This leakage may add anywhere between 30 percent and 180 percent of the nominal hydrogen orifice area to the total flow area. The leakage areas in the igniters run in XR103-3 were measured so that the actual H_2 flow could be determined.

- THREE NO-LIGHTS ENCOUNTERED WHILE TESTING RL10A-3-3B ENGINES WITHIN THE SHUTTLE/CENTAUR "G" START BOXES
- ALL THREE WERE RELIGHT ATTEMPTS
- EXPERIENCED MANY LIGHTS AT SAME CONDITIONS

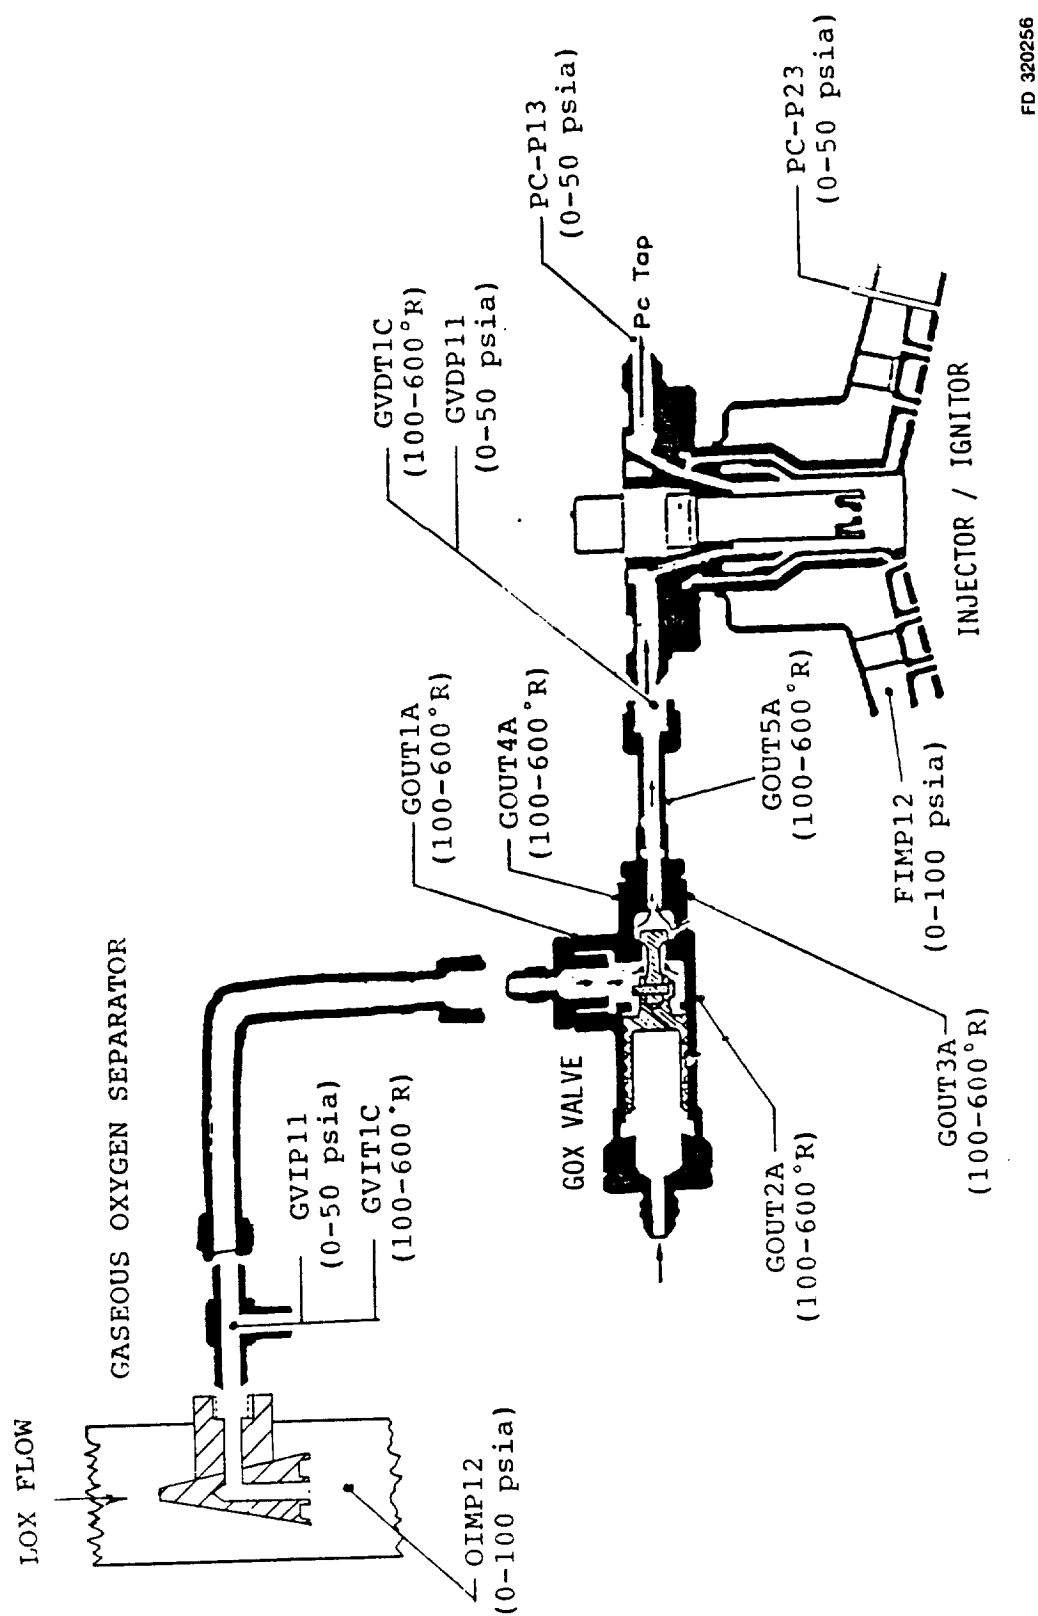
Figure 2. Igniter Study — Special Instrumentation

Special instrumentation was provided to monitor oxidizer pressures and temperatures in the GOX valve plumbing and igniter oxidizer supply lines, as shown in Figure 2. The igniter supply pressure and temperature were used to calculate igniter oxidizer flow. Appendix B outlines the methods used for calculating both chamber propellant flows and igniter flows. Figures 3 and 4 show the igniter/injector geometry and indicate the critical fuel metering holes and the oxidizer orifices. In addition, the location of the leakage gap between the injector sleeve and igniter is pointed out. This leakage can range anywhere from 30 percent to 180 percent of the nominal fuel metering hole area based upon current blueprint tolerances.

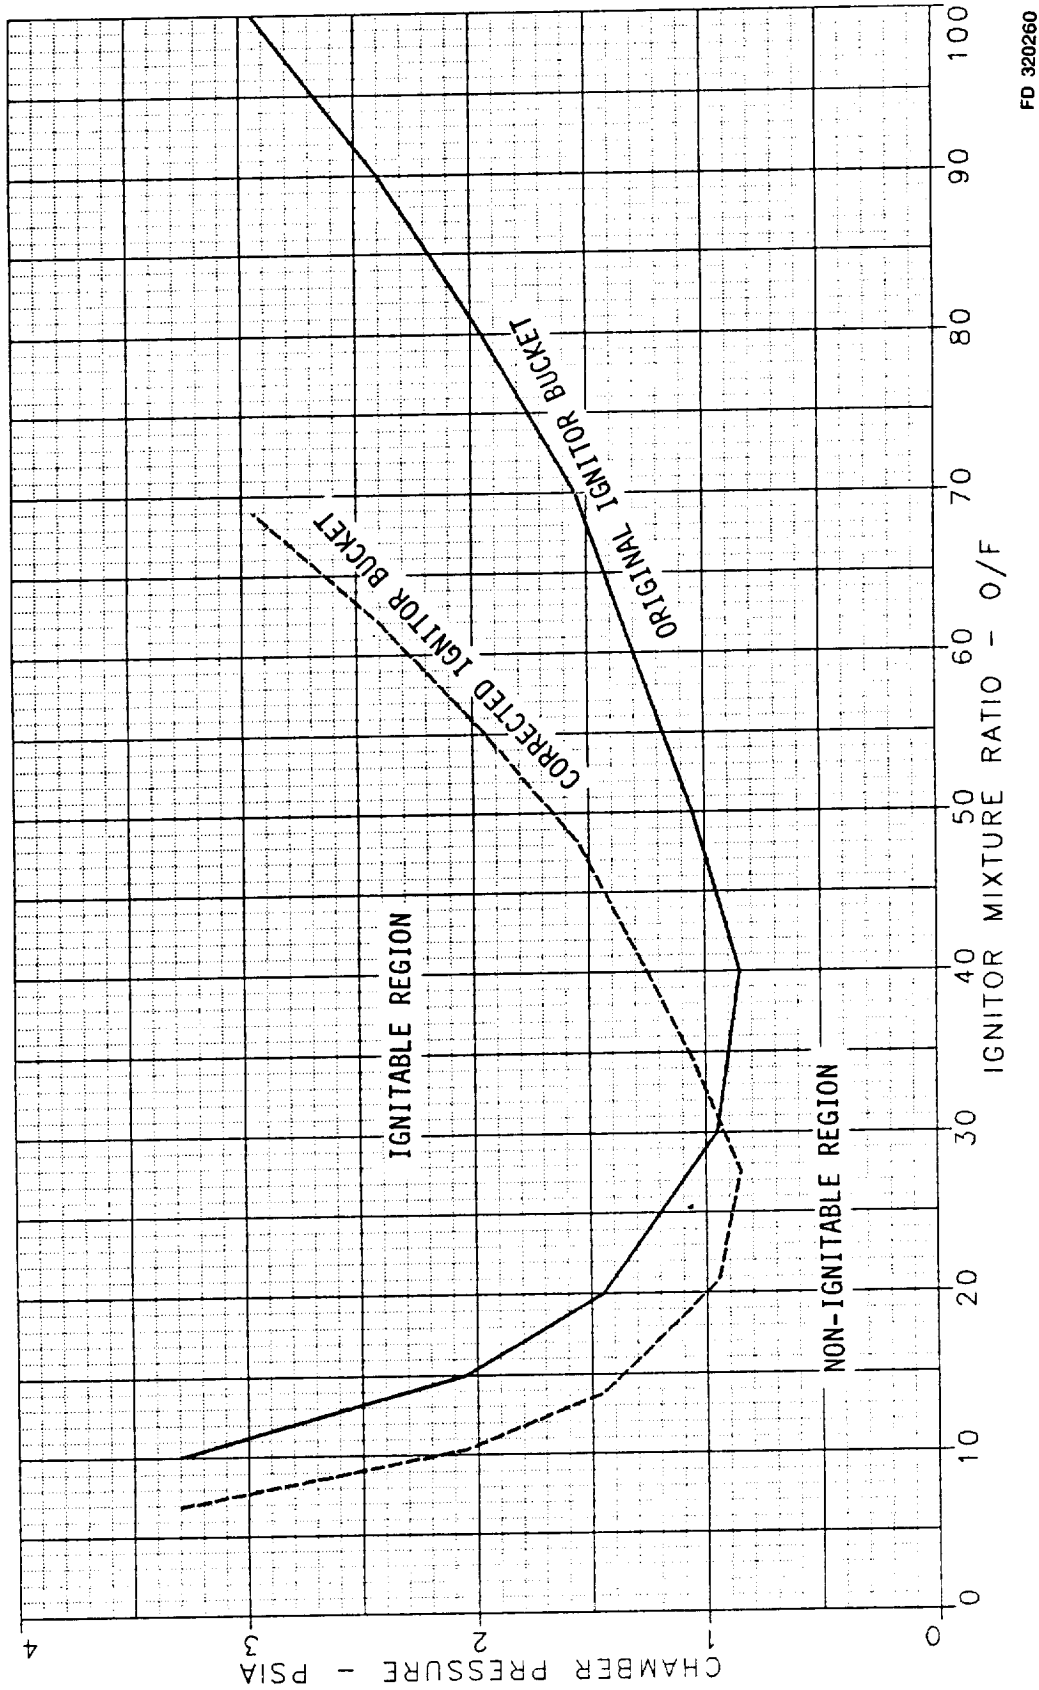
Figure 6. Igniter Bucket Corrected for Minimum H_2 Leakage

Figure 6 shows a plot of the existing igniter bucket (because of the shape of the ignitable region, it is often defined as "bucket"). At the time this was developed, the additional H₂ leakage path in the igniter was not considered, so the H₂ flow used to calculate O/F ratio should be corrected. The actual leakage area in the igniter which was tested is unknown, therefore, the actual amount of correction to be made is uncertain. However, it is certain that at least minimum leakage existed, and since this yields a conservative correction, the curve was corrected by this amount (+30 percent of H₂ flow). This corrected bucket is also shown on Figure 6.

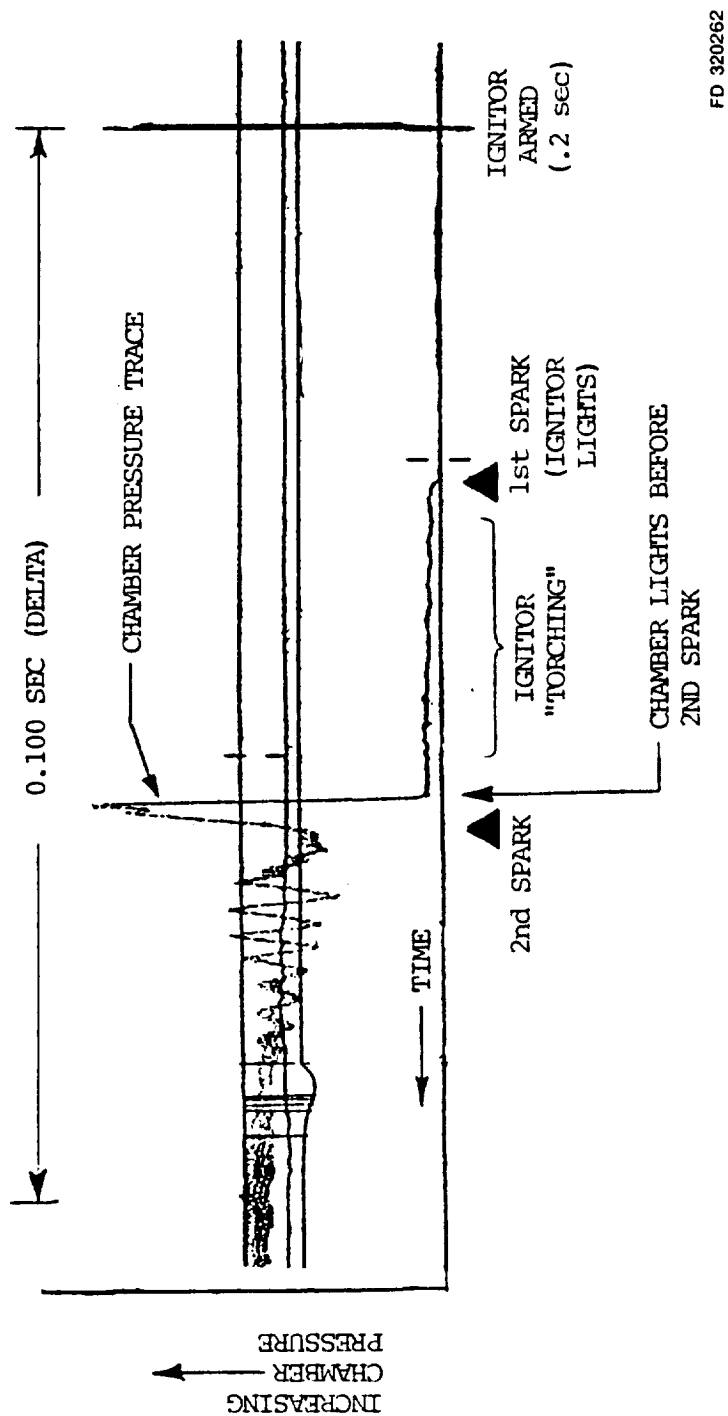
Figure 8. Chamber Pressure Trace for XR103-3 Run 41.01 Showing Igniter Light-Off and Chamber Light

Referring to Table 1, it is seen that in most cases the igniter lit on the first spark and the chamber lit some time later. This phenomenon is referred to as igniter "torching." In many cases the chamber lit between sparks and in run 37, the chamber actually lit at 0.750 second while the igniter was disarmed at 0.700 second. This torching phenomenon is clearly shown by O-graph data. The O-graph trace of chamber pressure (P_c) for run 41 is shown in Figure 8. A small jump in P_c occurs at the first spark indicating that the igniter has lit. The igniter then torches until the chamber lights, indicated by the large jump in P_c . Note that the chamber lights before the second spark. In other runs, the igniter torches for many sparks before the chamber lit. The reason that the igniter can torch without chamber ignition, even though the chamber is within its ignition bucket, may be explained by Figure 9. The igniter torches up near the fuel and oxidizer metering holes. Leakage hydrogen mixes with the combustion products nearer the tip of the igniter and dilutes the gases before entering the chamber. Ignition does not occur until sufficient energy is present in the combustion products.

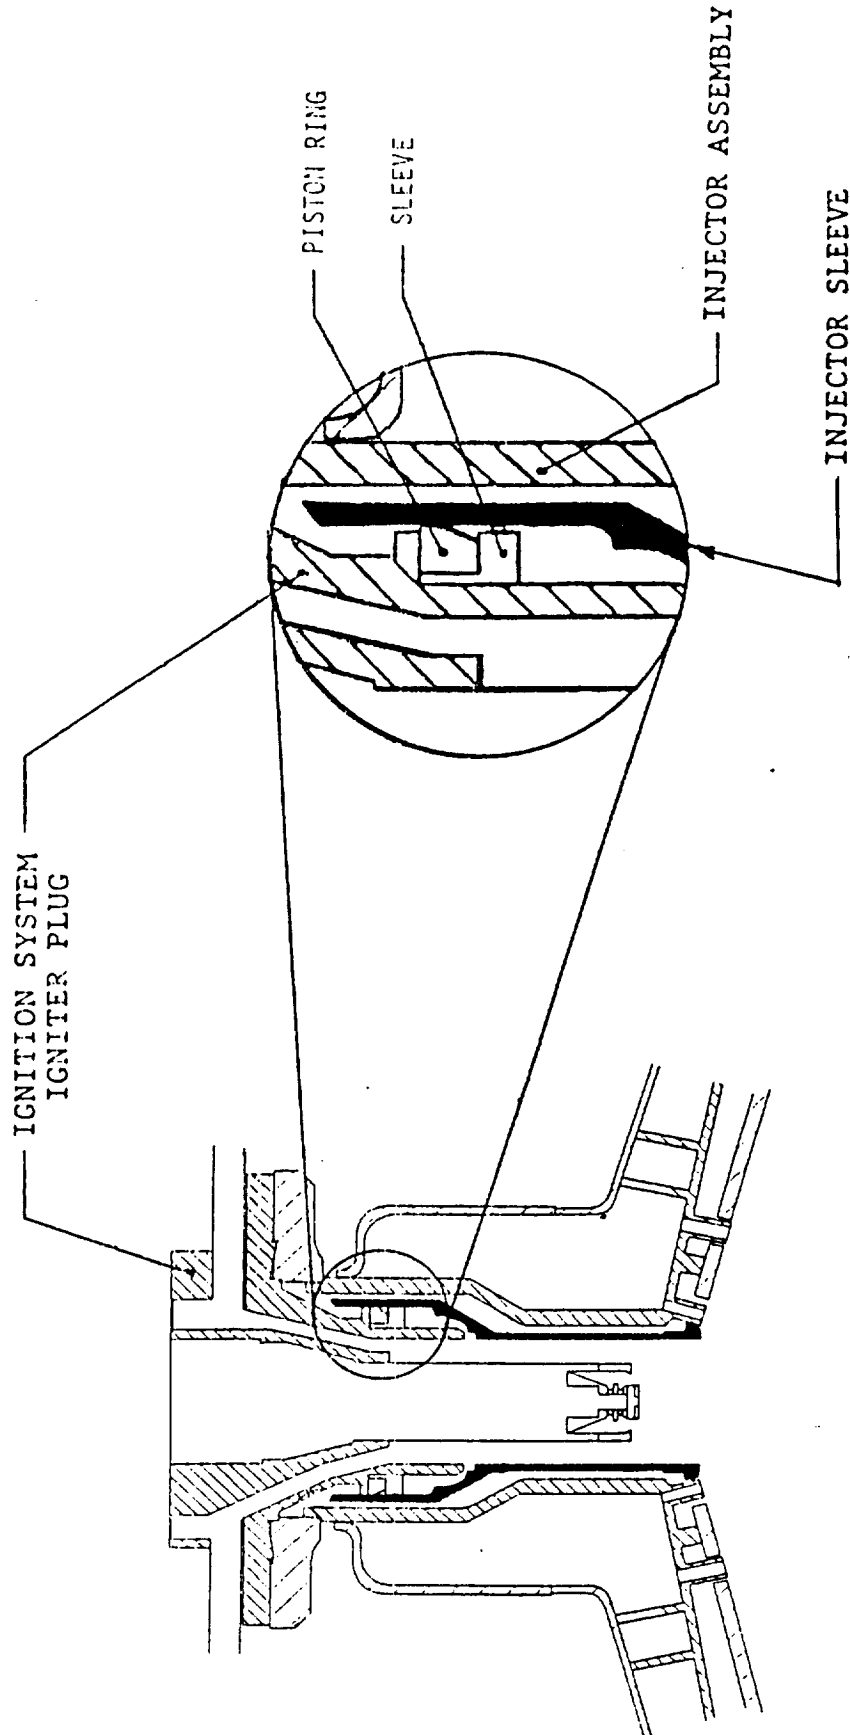
Figure 10. RL10 Igniter Leakage Control — Proposed Configuration Piston Ring Design Provides Controlled Leakage

Hydrogen leakage in the igniter can be significant and can adversely affect the igniter O/F mixture ratio to the point of delaying ignition significantly. However, indications are that unlit engines tend to move with time toward favorable ignition conditions so that ignition will occur in most all cases, although some delay may occur. To avoid the possibility of excessive hydrogen leakage, a leakage control scheme should be implemented. The leakage should not be eliminated entirely, as it has always existed and igniter performance and durability has historically been good, but should be held to the minimum level that currently exists. One possible scheme to do this is shown in Figure 10. This piston ring arrangement would provide a positive seal between the igniter and the injector sleeve and may contain slots for controlled leakage. This arrangement is a concept only and no detailed design has been performed at this point.

- A hydrogen leakage path in the igniter, which has been overlooked in previous ignition investigations, has been identified. The injector/igniter clearance gap (minimum 0.0005 in., maximum 0.002 in.) creates H_2 leakage between 30 percent and 180 percent of the nominal flow through the igniter fuel holes. Incorporation of a seal to control this leakage to the 30 percent level is recommended.

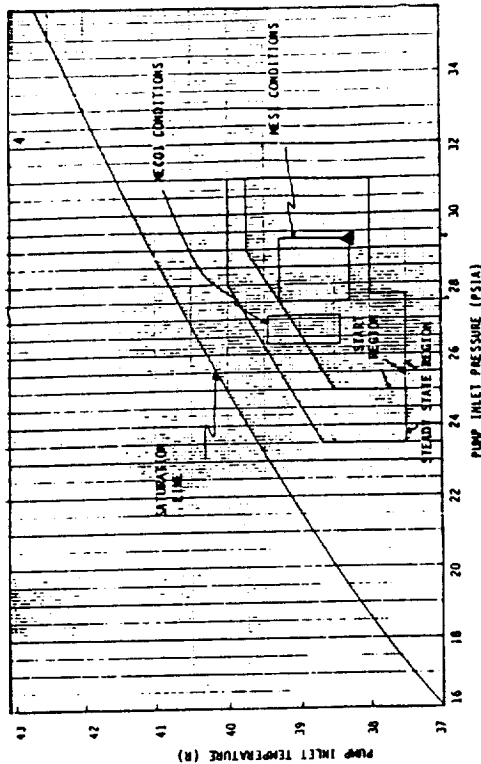
Figure 12. AC-66 Inlet Conditions — First and Second Starts (Sheet 1 of 2)

An ignition study was done for Atlas/Centaur launch No. 66 (AC-66) using the predicted inlet conditions. The worst case inlet conditions were used for both starts as shown in Figure 12. The igniter conditions were predicted using an RL10 transient start simulation program. The results are illustrated in Figure 13. The top two figures show igniter conditions assuming nominal igniter flow areas and nominal leakage size (0.00125 in. gap) with the worst case inlet conditions (Figure 12). These conditions would be those normally expected, and as shown, the igniter is well within the ignitable region for most of the transient. The bottom two plots show what happens if all worst case tolerances are considered (maximum H_2 area and minimum O_2 area) along with the largest leakage area and worst inlet conditions. The igniter is still within the ignition bucket during the initial part of the transient, when ignition should occur, but does move out of the bucket at about 0.22 second.

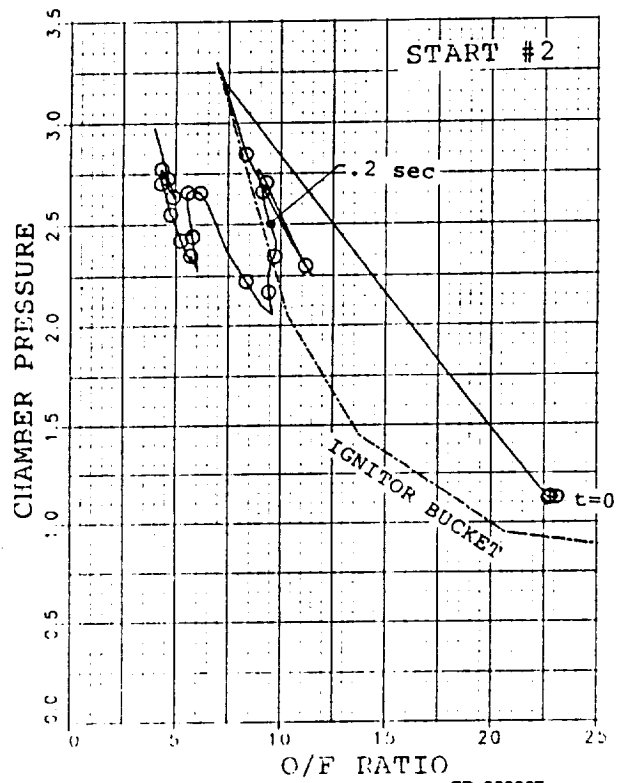
Figure 13. AC-66 Predicted Igniter Conditions

- Start transient modeling for Atlas/Centaur shows that if an igniter with worst case leakage is combined with the worst case Atlas/Centaur specification inlet conditions (low LOX pressure, high fuel pressure), the igniter mixture ratio will be out of the start bucket. The possibility of this situation, even though unlikely, makes fuel leakage control mandatory for the full range of Atlas/Centaur specification inlet conditions. Until incorporation of this control the vehicle propellant inlet condition range must be limited.
